**SECOND FIVE-YEAR REVIEW REPORT FOR  
DEPUE/NEW JERSEY ZINC/MOBIL CHEMICAL CORP.  
SUPERFUND SITE  
BUREAU COUNTY, ILLINOIS**

**Prepared by  
Illinois Environmental Protection Agency  
Springfield, Illinois**

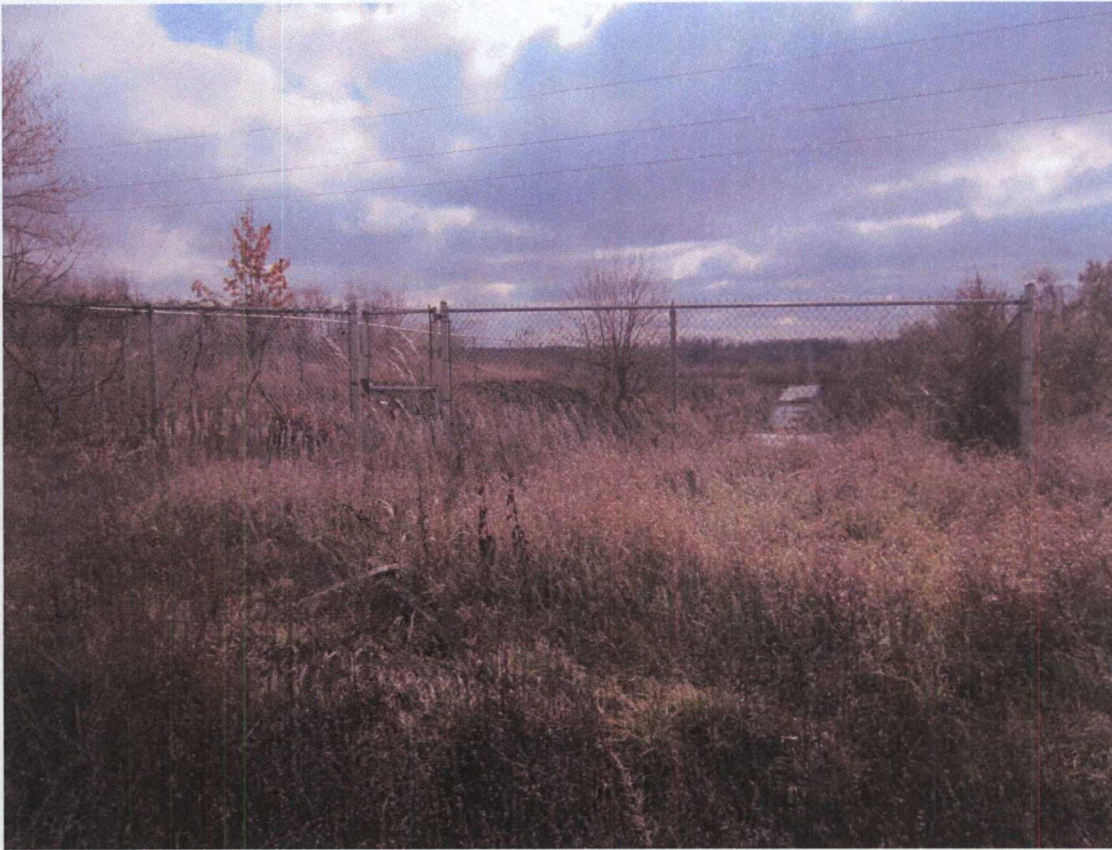
November 13, 2014

Fence at the head of  
the South Ditch.

No significant issues were noted with the condition of the South Ditch, though a section of the fence on the west side of the ditch was damaged at its southern extent. The gate and fence at the head of the South Ditch, where the ditch is most accessible to the public, was intact, though the sign on the gate (noted in the photographs from the first FYR report) was missing. The fence damage noted is likely due to the action of floodwaters or other weather-related elements rather than vandalism.

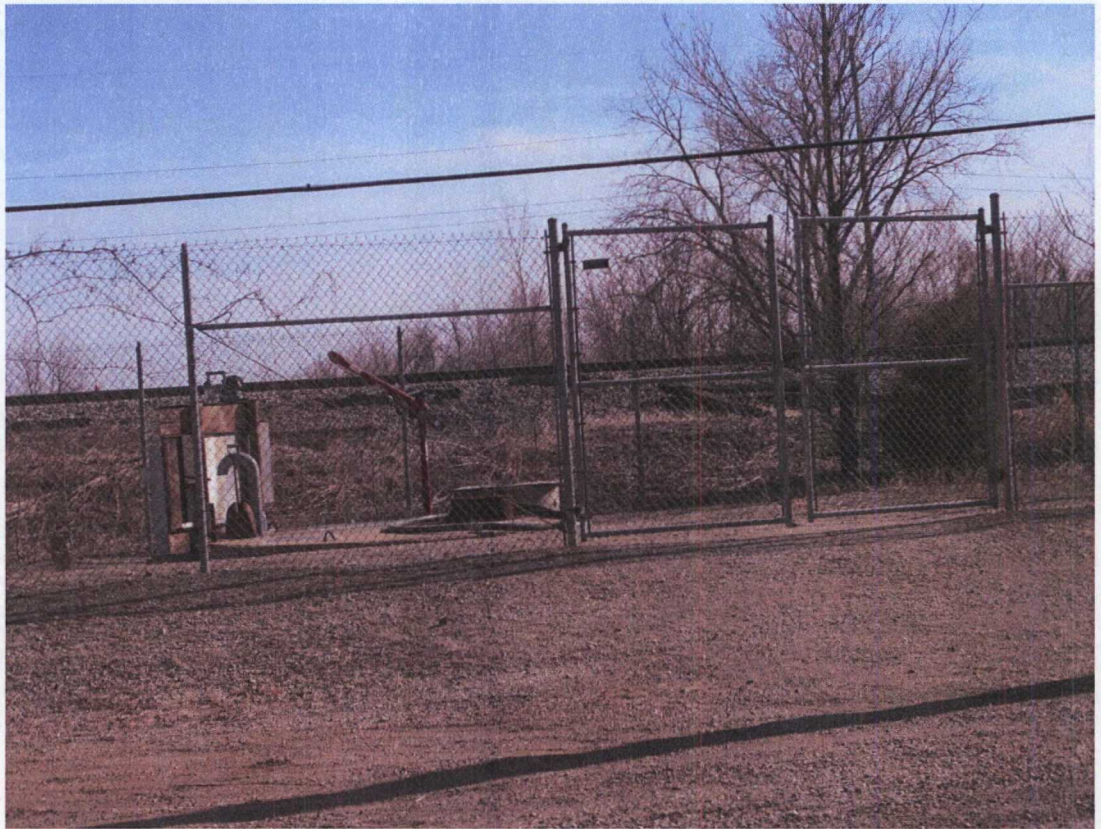
Lift Station  
April 1, 2015

While the lift station is referenced within this FYR, the lift station and the IWTP are considered part of OU3. The lift station continues to operate as designed and routine maintenance is conducted. During the period of this FYR, the IWTP and lift station remain in compliance with ARARs and the ICO. Annual Operation and Maintenance (O&M) costs have not been provided by the PRPs, but are characterized by one of the PRPs as "minimal," and any costs are absorbed into periodic inspections of the remainder of the property.

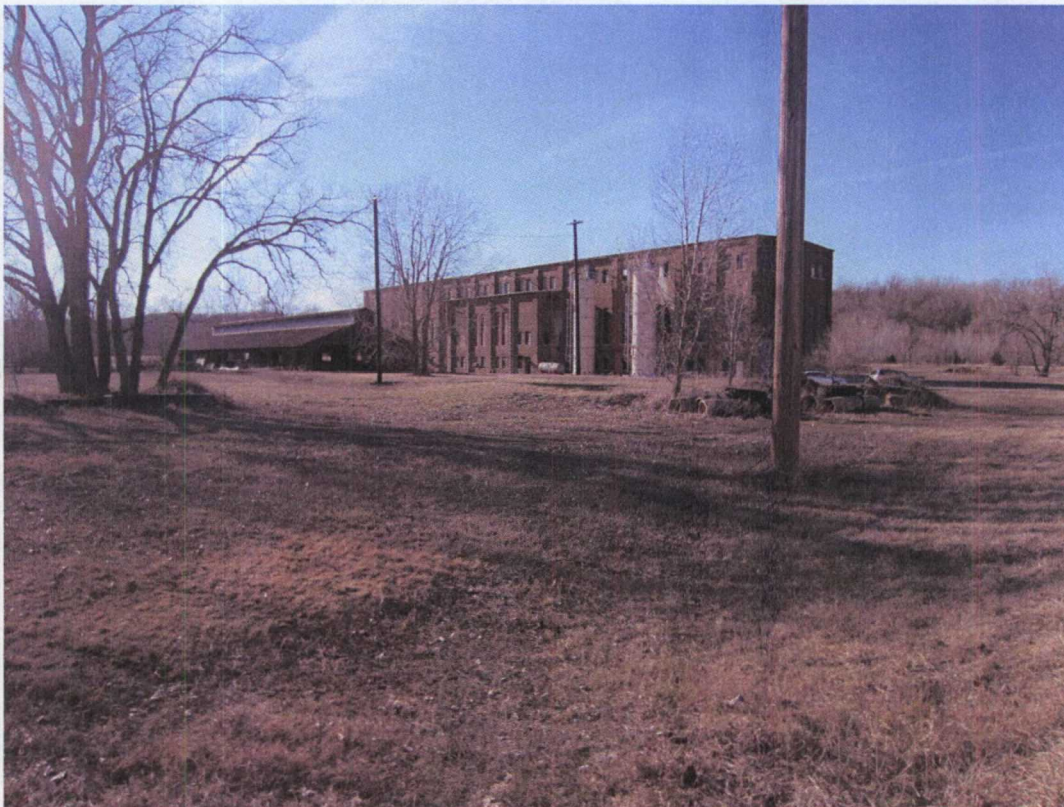
Interim Water Treatment Plant ((WTP)  
April 1, 2015

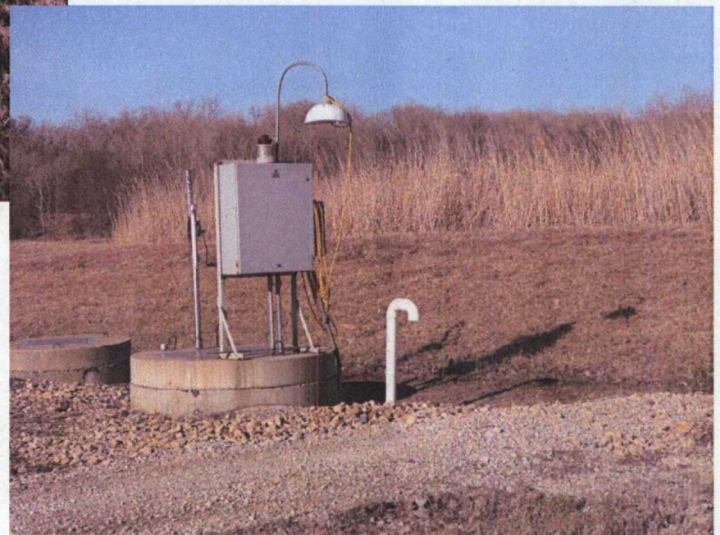
April 1, 2015

Below, lift station for CAMU

- S. Weberski
  - Weekly visual inspection of berm surrounding CAMU, also inspect pump station
  - Pump station has 2 pumps, can be cycled at operations panel to confirm they are operating
  - Seasonal mowing of berm, about 1/month
  - Pump pit maintenance based on manufacturer's recommendations
